TÜV NORD Mobility Inc.

Report

1217GWC0744

Re: : Pre purchase inspection AJAK 709
Your ref.: : ch_1BTwPvBS2By3EvCCi
Client : Giovanni Trappatoni
Säbener Str. 1, 72458 British Columbia
Vehicle holter :
Order no. : ch_1BTwPvBS2By3EvCCi
Contract no. : ch_1BTwPvBS2By3EvCCi
Licence plate number : AJAK 709
VIN : 2T1BU4EE8BC715700
Commissioned by : 12/07/2017
Inspection date : 12/08/2017
Place of inspection : 14 Evergreen Terr.;British Columbia;Canada
Inspected by : Jennifer Krista
Present at inspection : 620 Princess Ave. London, ON

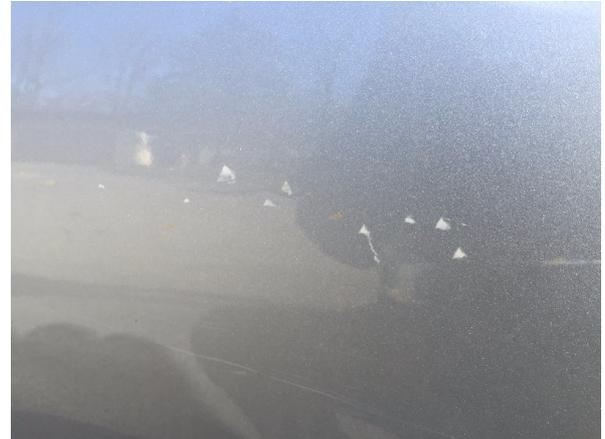
Serial number	Designation - Type of repair	Repair costs		Value reduction	
		labor time AW	material \$	Approx. CAD (without value added tax)	Approx. CAD (without value added tax)
signs of use					
1	left rear door-left rear door scratched - smart repair paint		90.00	90.00	76.50
2	rear bumper-rear bumper scratched - smart repair		90.00	90.00	76.50
	<u>Intermediate sum:</u>			180.00	153.00
Sum total	approx. without VAT (CAD)			180.00	153.00

Photo 14: left rear door scratched - smart repair paint

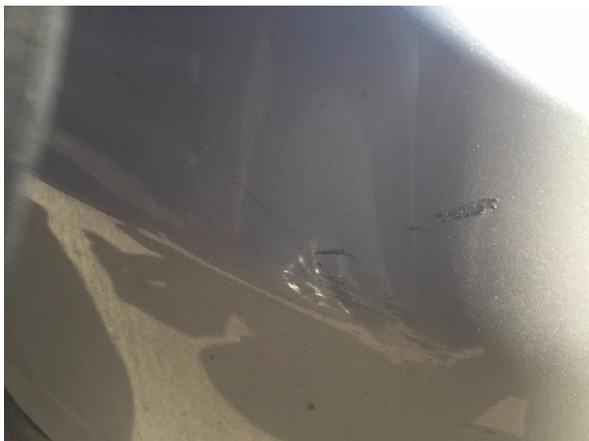
Photo 15: rear bumper scratched - smart repair
